# 2015 BaoJun 610 After the replacement of airbags, the fault alarm lamp flashes to solve the operation method

Actual Measurement: BaoJun610, 2015, VIN=LZWADAGA2EB2\*\*\*\*\*, See as pic.

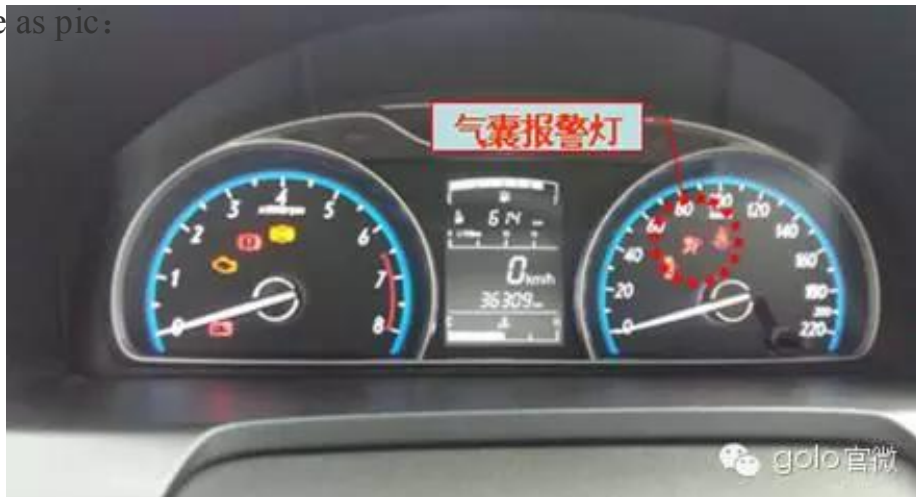
Fault phenomenon: After replaced new air bag and ECU, Instrument airbag warning light flashes regularly, see as pic:
