2013 Land Rover Freelander-2 Diesel Vehicle Engine Failure.

Land Rover Freelander-2 Diesel Car, 2013款, VIN=SALFA2BD7EH3*****。

Fault Phenomenon: Sometimes it is very hard to start the car, so the engine fault light is on. It displayed 3 error code in the engine system when used X431 tablet to test.

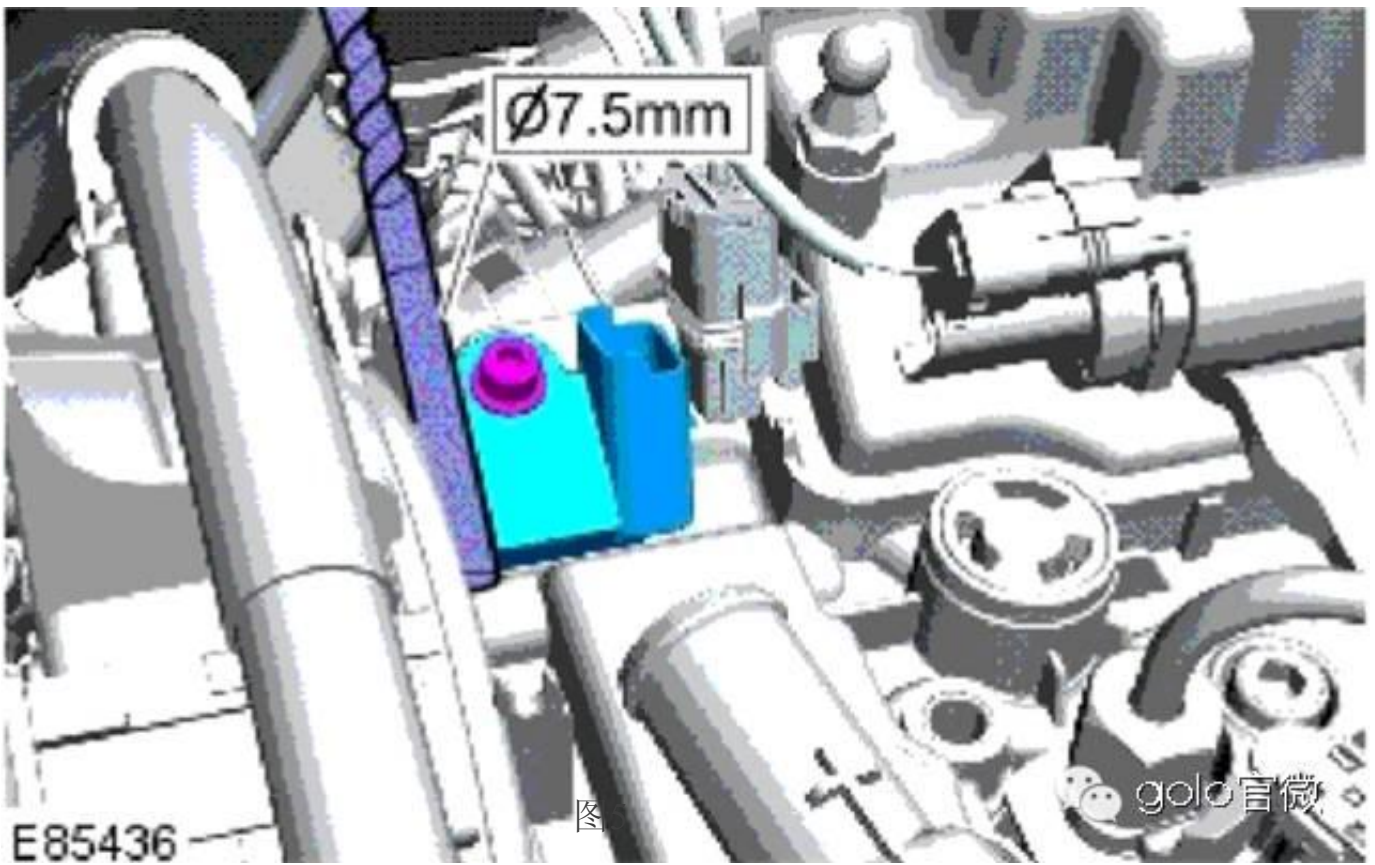
After checking the voltage of the signal line of the camshaft position sensor, it is decided to replace the camshaft position sensor. Install the camshaft position sensor to ensure that the clearance between the CAM position sensor and the end face is 7.5 mm. As shown in figure 5: the sensor steps between the end face and put a 7.5 mm diameter bit, clearance is too small will wear the CAM position sensor, lead to damage of the CAM position sensor, the gap is too big, can lead to weak signal.
