【 X431Remote Diagnose】 2014ShangHaiVW new POLO Fault Code“P106900—Collision cut have trigger \\'solve operation method.

ShangHai VW new POLO, 2014, VIN=LSVGZ26R3E20*****, pictures as follow.

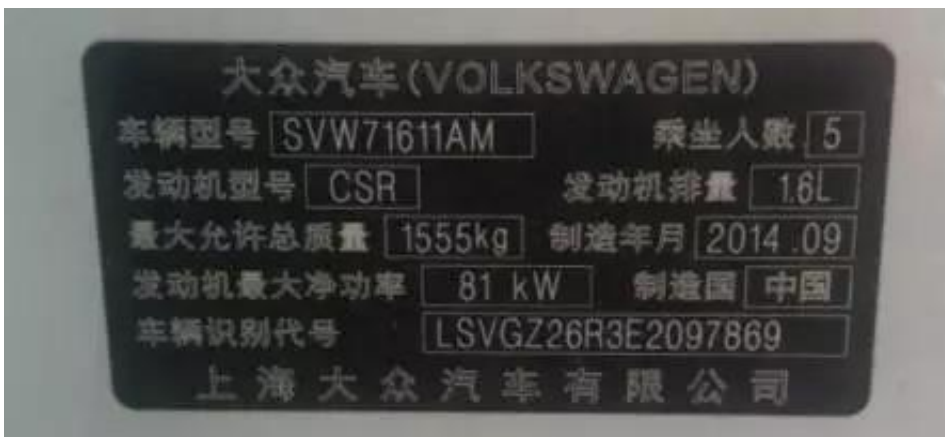
The dashboard turned to system failure warning lights, system failures code "P106900 - collision cutoff has been triggered".

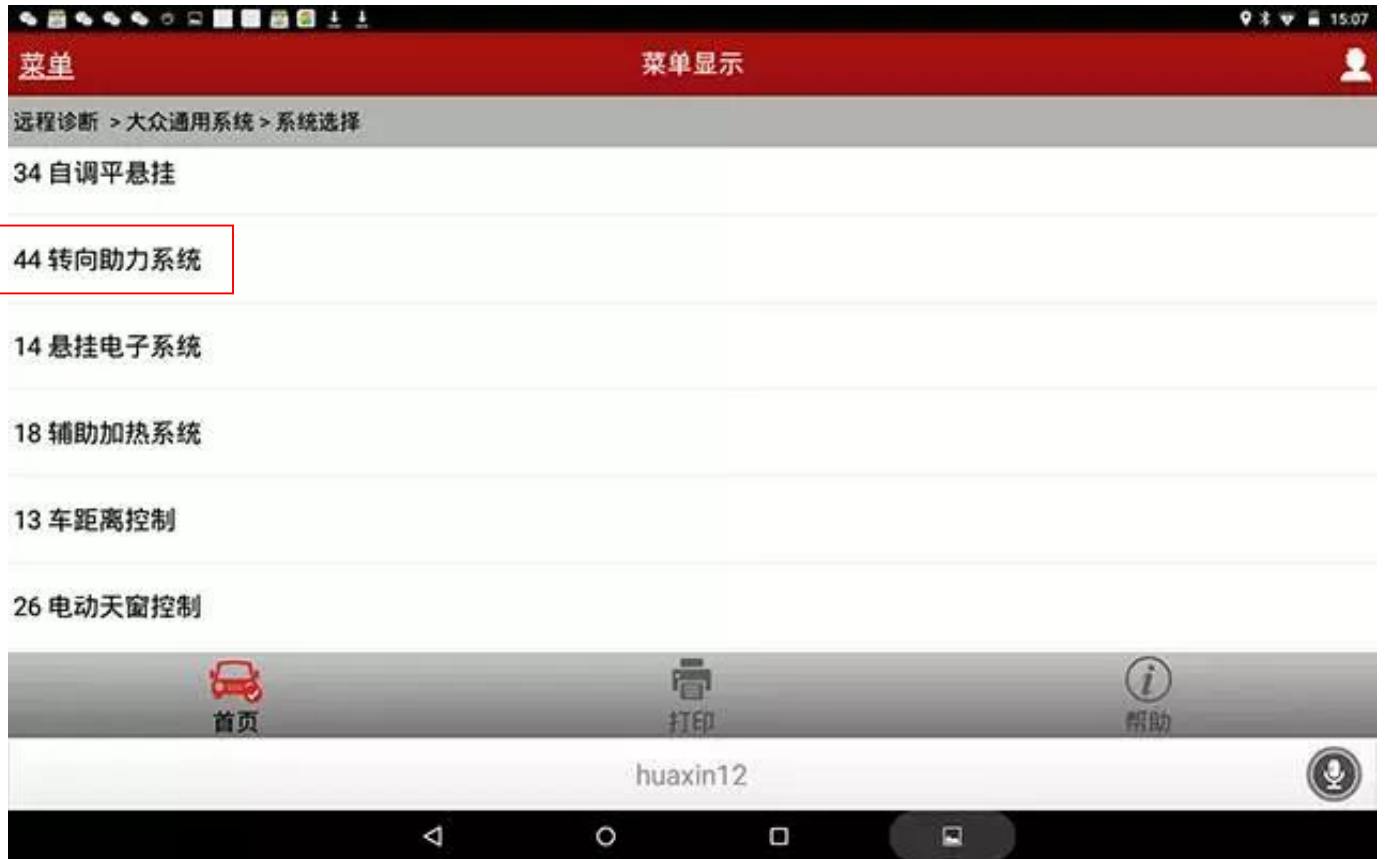
pic1

- 1.Select ShaiHai VW V21.61;
- 2.Select VW General System ;
- 3.Select system selection;
- 4.Select 44 Steering booster system, see as Pic1

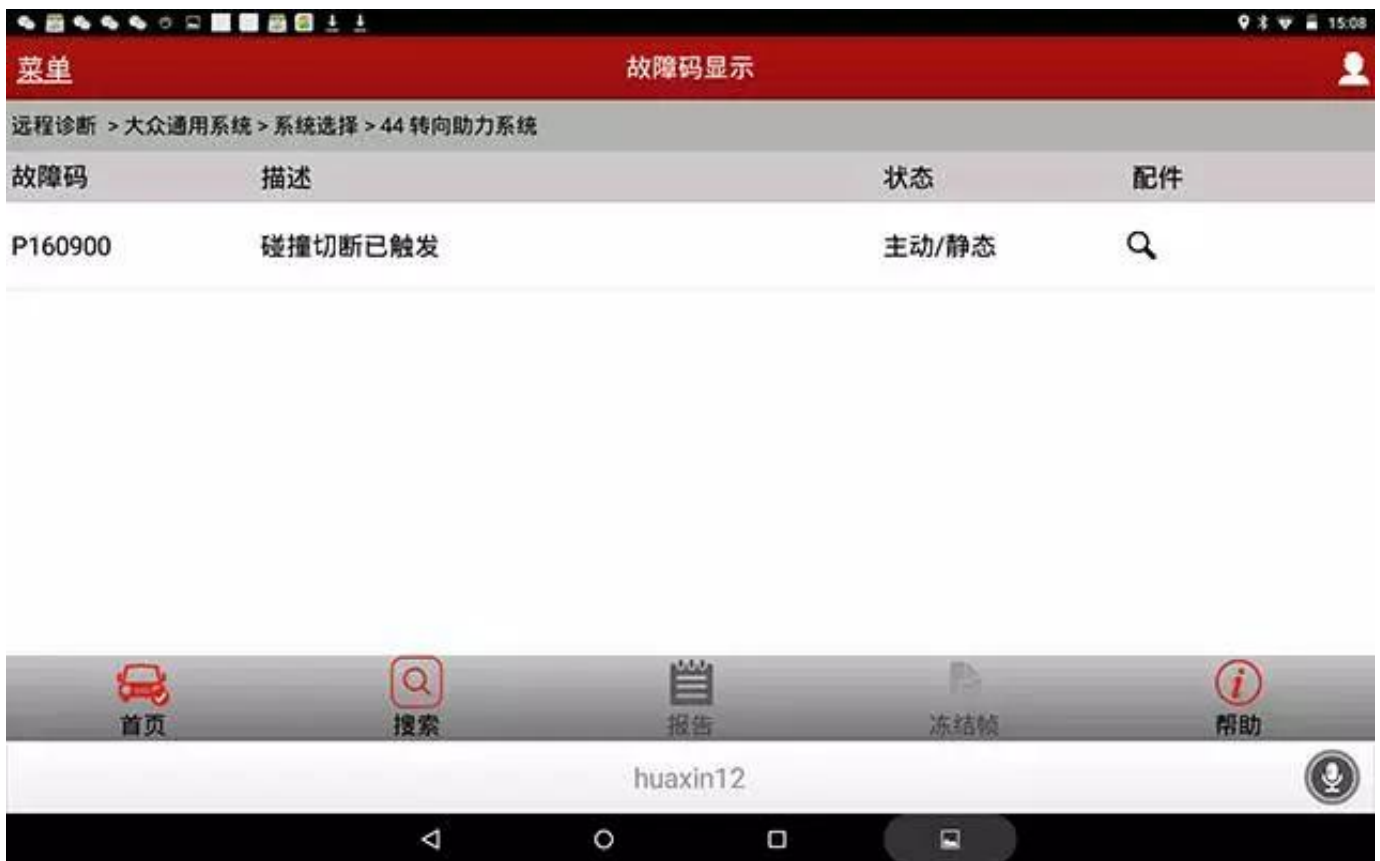
pic2

5. Perform [read fault code] display "P106900 - collision cutoff has been triggered" as shown in figure 2, and the next step will be carried out when the fault code cannot be cleared.
