【X431 operation guide】 The solution of DTC for 2011 Prado ABS system "C120a, ECU initialization is not completed"

Vehicle module: Toyota Prado, 2011 models, VIN=JTEJU3FJXB50*****

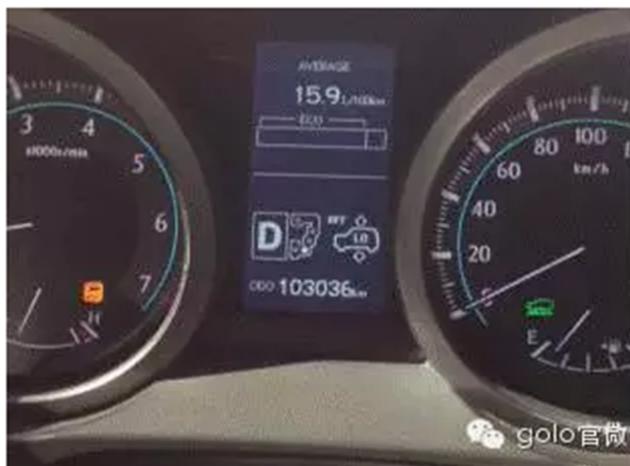
Picture 1

The following shows an example of a C120A fault code after the replacement of the ABS pump assembly by 2011 Prado:

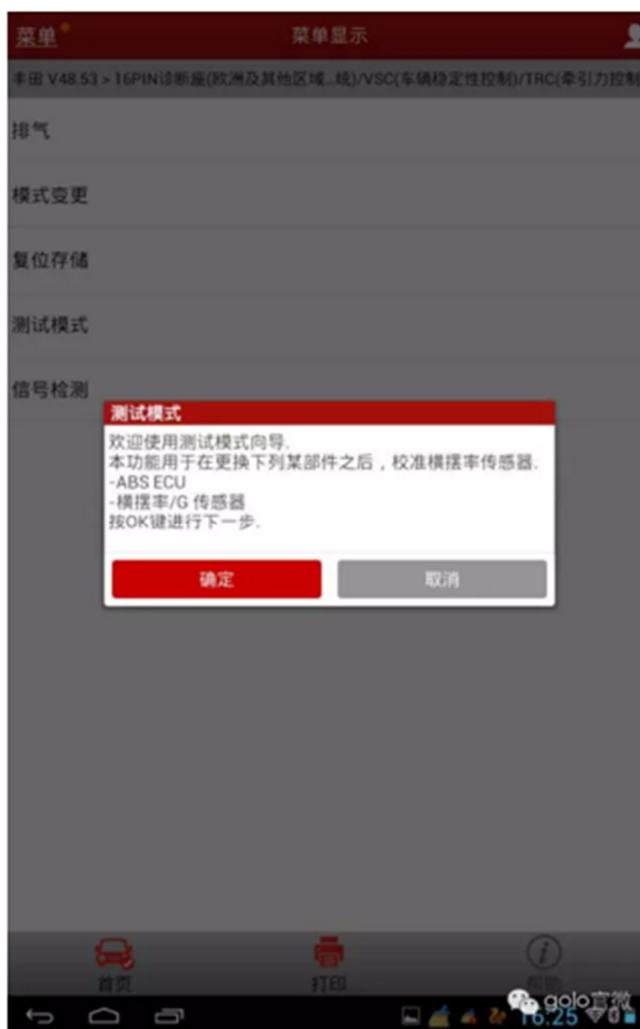
Picture 13

15. Prompting: This function is performed when the "ABS ECU" and "Yaw rate/G sensor" are replaced, as picture 13.
