LAUNCH X-431 PAD III Engine Cover Not Closed Troubleshoot

2009 C200，VIN number：LE4GF4BBXAL10****;

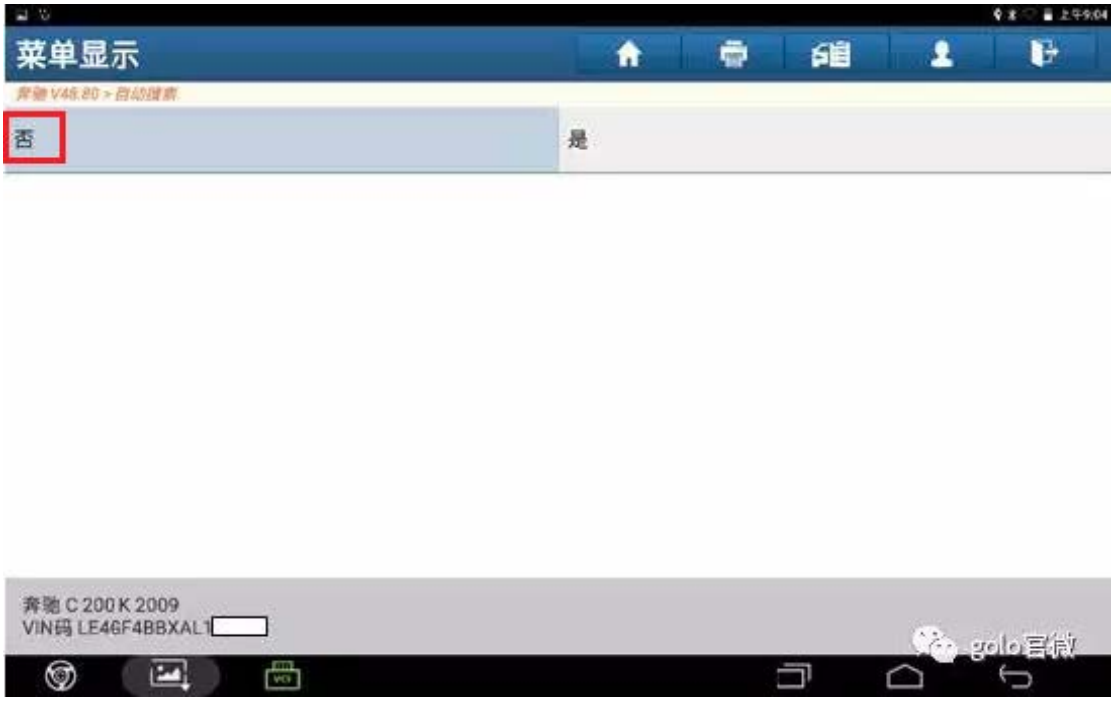
Picture 5

5).Choose item 001 change "Yes" into "No";
