【 X431PRO Measured articles】 2011 Maserati M145 maintenance lamp zero operation method

Measured models: MaseratiM145, year2011, VIN=ZAMKK39E2B00****

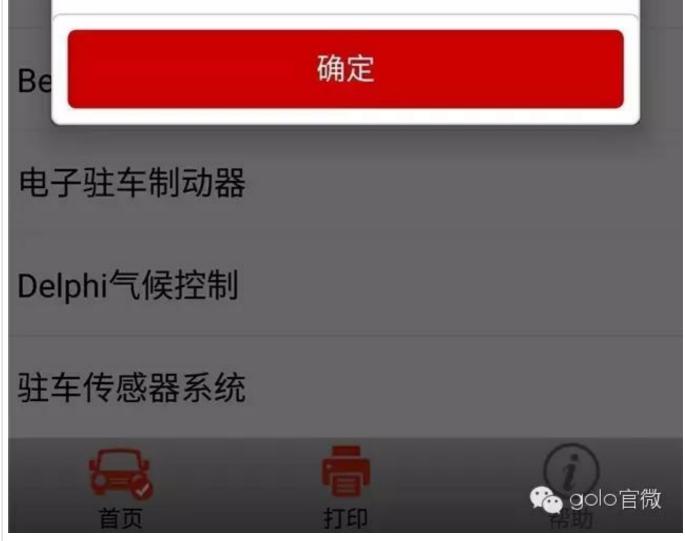
picture1

1. T urn ignition switch ON: 2. Choose "Europe"; Select "Maserati" V10.03 version; 3. Select "GRANTURISMO" models: 4. 5. Select "M145"; 6. Choose "gasoline"; Select "System Scan": 7. Select "IPC-dashboard combination", prompting ECU ID information, as shown in Figure 1; ★ ⑤ 46+ull ■ 10:12 菜单显示 登录 玛莎拉蒂 V10.03 > GRANTURISMO > M145 > 汽油 > 系统 防抱死制动系统8 TRW安全气囊系统 自动变速箱 版本信息 ID:00000249709 M No

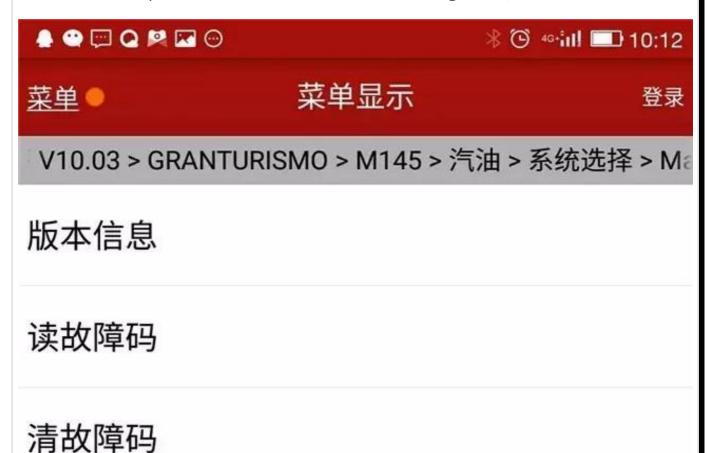
picture2

9. Select "special features", as shown in Figure 2;

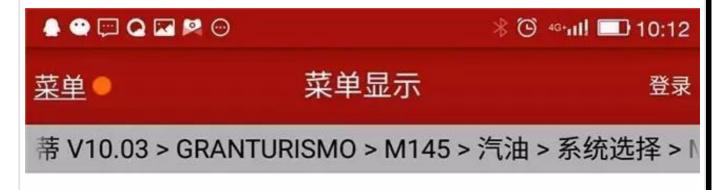
picture3

10. Select "maintenance information reset", as shown in Figure 3;

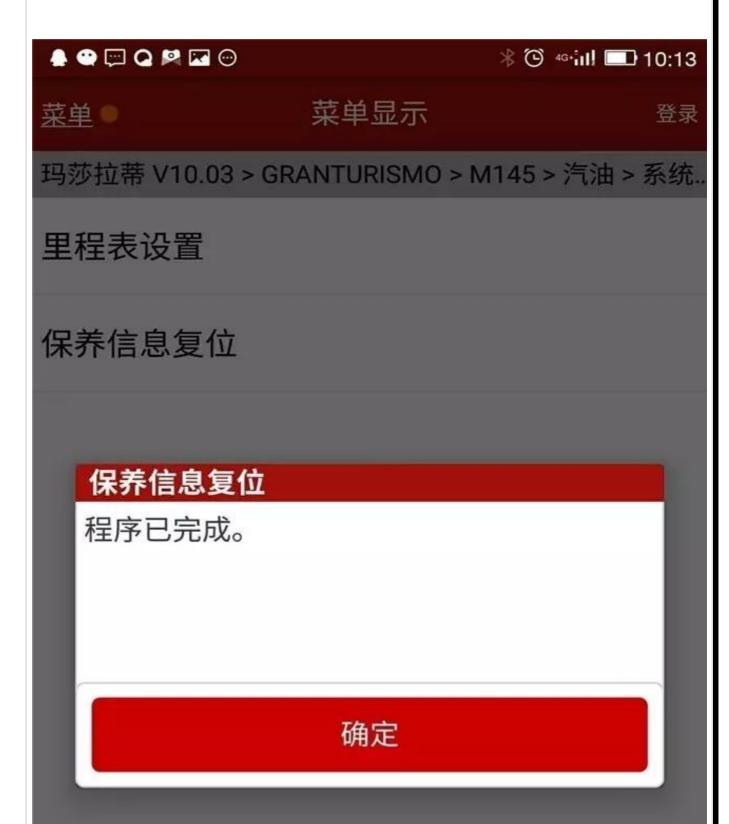
picture4

11. Pay attention to reset service prompt information to ensure that the correct combination of the date on the instrument set, shown in Figure 4;

为了成功执行复位,请确保正确设置仪表组合上的日期!

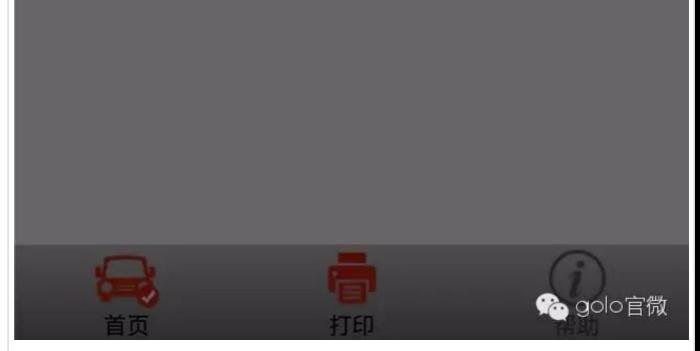
picture5

12. After determining, the prompt program has been completed, as shown i Figure 5, the operation ended.
